The Road Inventory of Willapa National Wildlife Refuge Ilwaco, WA

Prepared By:
Federal Highway Administration
Central Federal Lands Highway Division
April 2013

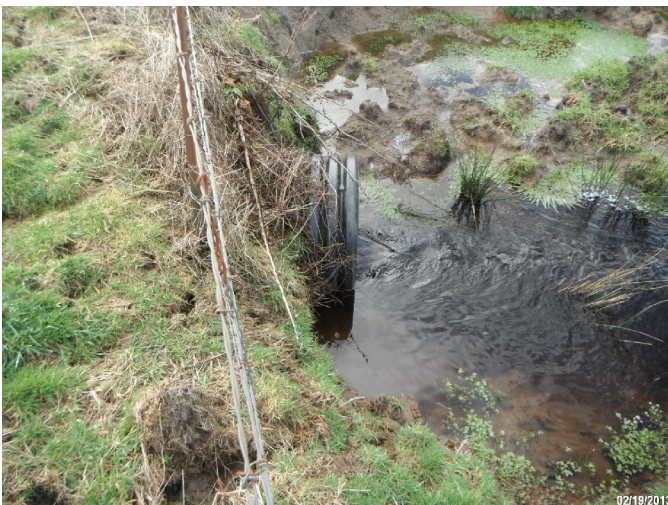
Photo: WILL_C4_0014 Route: 400-002-0.36
Plastic WCS Flashboard Riser 30ft long 24in dia. 2ft deep
New Asset# NA

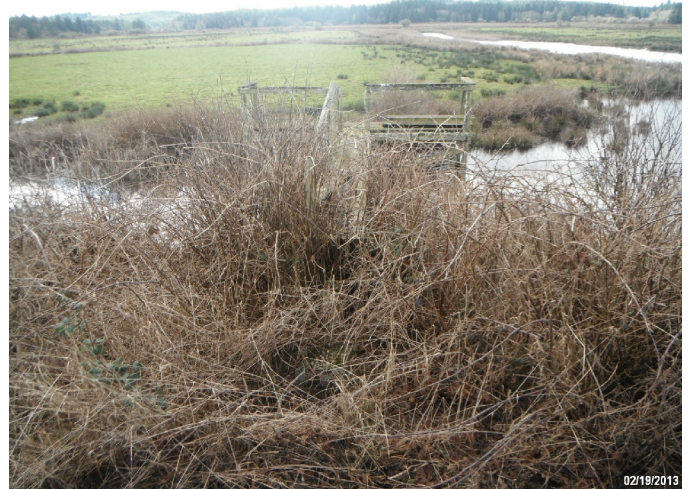
Photo: WILL_C4_0019 Route: 400-003-0.85
2 Metal WCS Flashboard Riser 70ft long 48in dia. 10ft deep
New Asset# NA

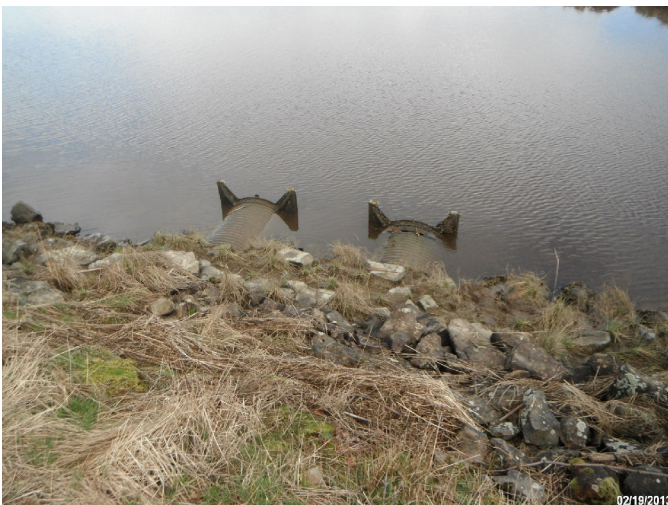
Photo: WILL_C4_0020 Route: 400-003-0.85
2 Metal WCS Flashboard Riser 70ft long 48in dia. 10ft deep
New Asset# NA

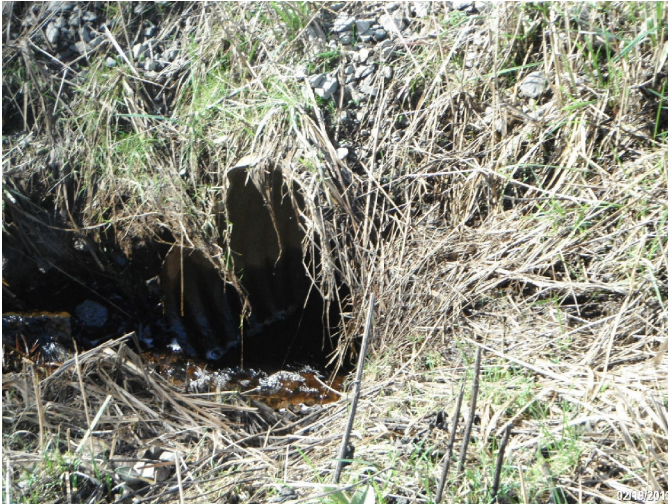
Photo: WILL_C4_0025 Route: 402-001-0.08
Metal Culvert 20ft long 18in dia. 2ft deep
Asset# NA

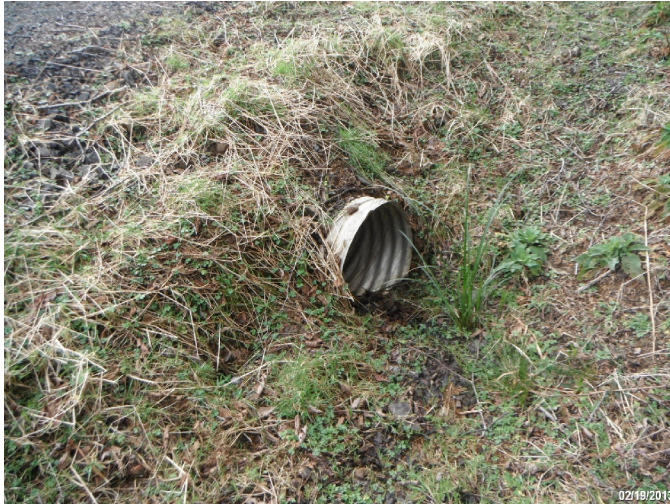
Photo: WILL_C4_0060 Route: 404-001-0.04
Metal Culvert 30ft long 24in dia. 3ft deep
Asset# NA

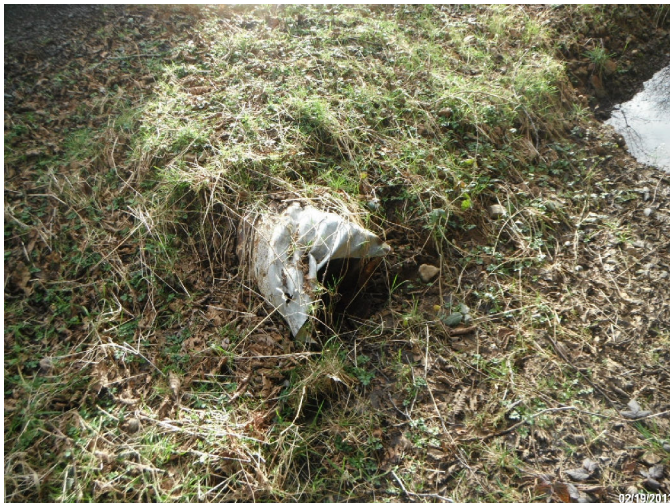
Photo: WILL_C4_0062 Route: 404-001-0.16
Metal Culvert 30ft long 24in dia. 3ft deep
Asset# NA

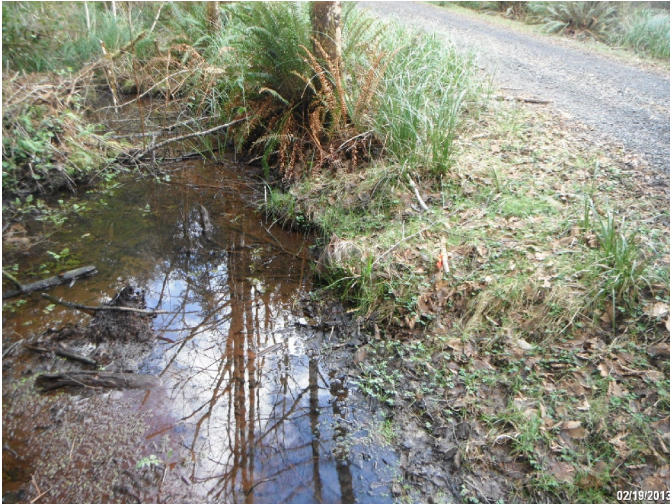
Photo: WILL_C4_0066 Route: 404-001-0.35
Metal Culvert 30ft long 24in dia. 3ft deep
Asset# NA

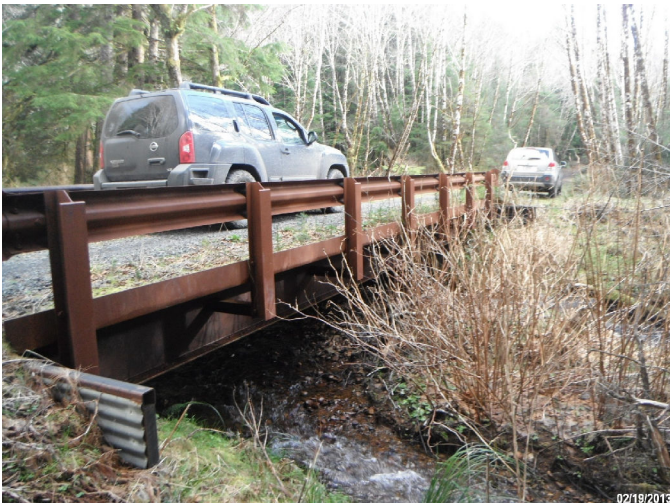
Photo: WILL_C4_0068 Route: 404-001-0.4
Gravel Bridge NBIS:NA
WILL_C4_0069 Asset# NA

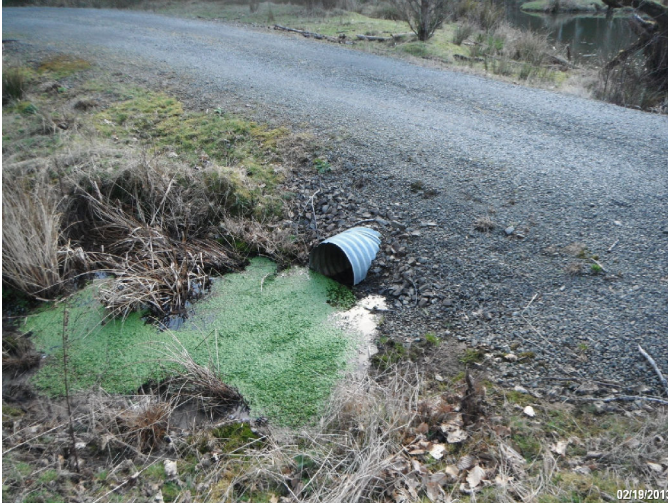
Photo: WILL_C4_0077 Route: 802
Metal Culvert 30ft long 24in dia. 1ft deep
Asset# NA

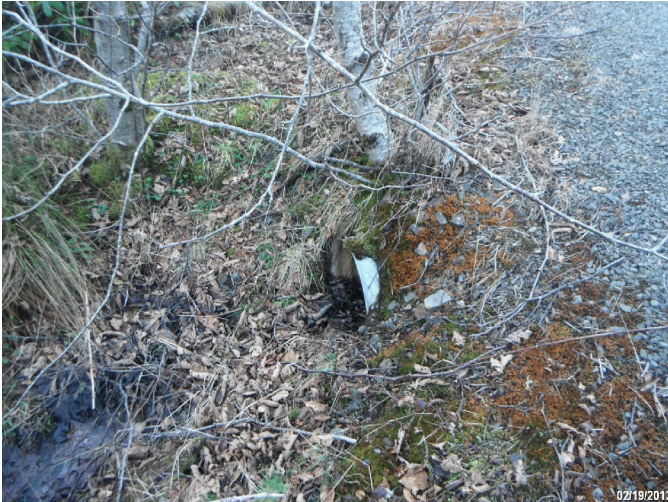
Photo: WILL_C4_0079 Route: 802
Metal Culvert 30ft long 24in dia. 1ft deep
Asset# NA

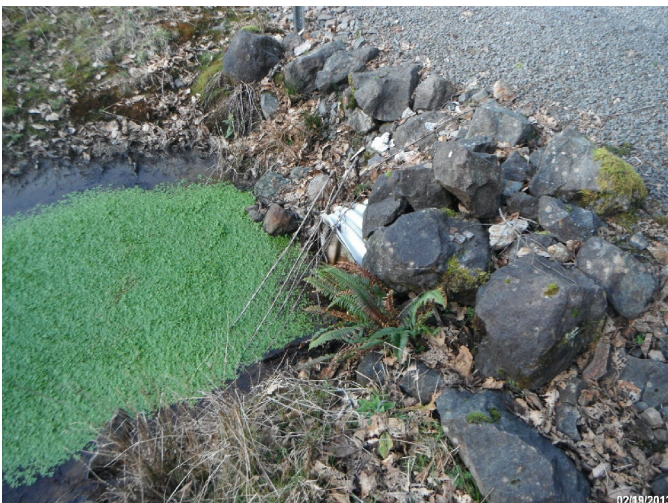
Photo: WILL_C4_0081 Route: 802
Metal Culvert 50ft long 24in dia. 1ft deep
Asset# NA
